Appendix B: Schenley/ Junction Hollow

Appendix C: Sheraden Park

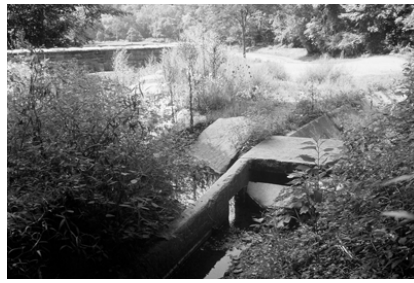
A

A—A broken stormwater pipe. This pipe probably originates from the Schenley Park golf course and/or West Circuit Drive. Erosion from this location and other similarly deteriorated infrastructure contributes to sediment buildup in the Panther Hollow stream and Panther Hollow Lake.

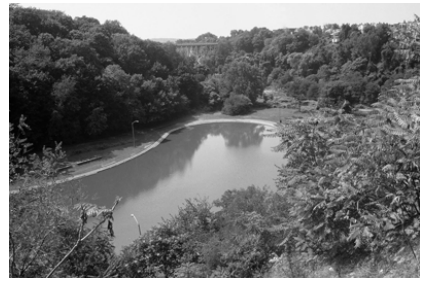
B

B—In the right foreground is the diversion structure for Panther Hollow streams, just above the lake. Dry weather "base flow" goes left out of the concrete structure, under a stone bridge, and into Panther Hollow Lake. Very high storm flows go to the right, into the concrete ditch around the lake.

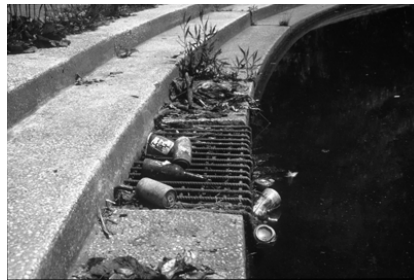
D

D—Tim Collins standing on the drainage inlet where the ditch around Panther Hollow Lake flows into the combined sewer system. This is one of two points where all the stream water from Panther Hollow drops into sewers, the other being a drain on the edge of the lake.

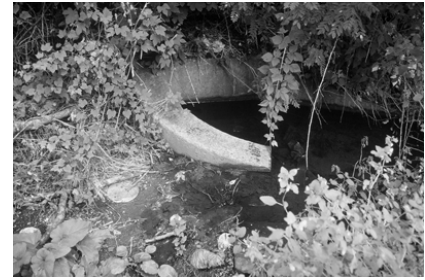
D2

D2—This drain on the edge of Panther Hollow Lake flows into the combined sewer system.

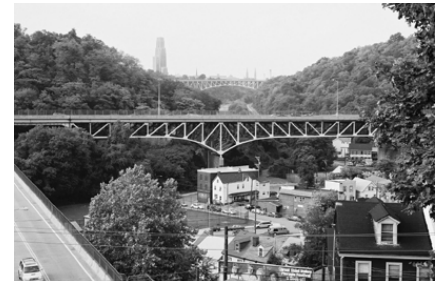
J

J—A portion of the Boundary Street neighborhood, from underneath the Parkway East bridge, looking southwest toward the Monongahela River. Note the density of buildings, the bridge piers, and the topography—between here and the river the land rises.

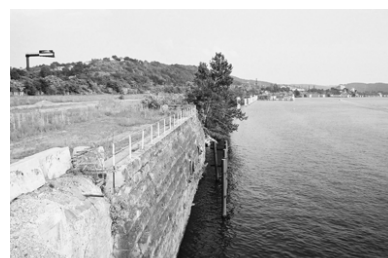
L

L—The exit of the Four Mile Run culvert at the edge of the Monongahela River. This brick-lined culvert is large enough for a small motorboat. It extends roughly 200 yards inland to the regulator structure that keeps dry-weather flows from the upstream combined sewers from reaching the river. In wet weather, combined sewer overflows reach the Monongahela from this culvert. The date on the keystone is 1892.

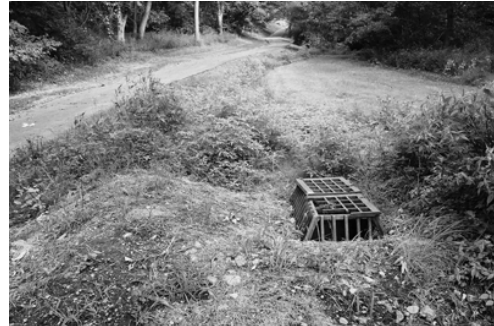
a—The tiny remnant stream in a side branch of the upper valley flows down the middle of this picture, and into an inlet to the combined sewer system in the lower right.

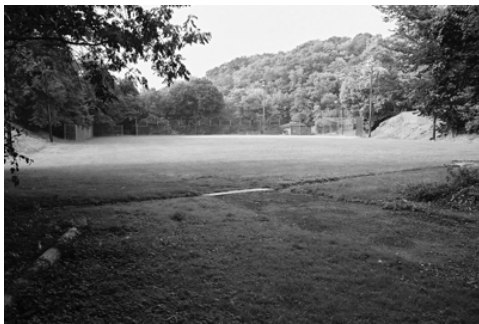
b

b—A drain that catches runoff in the upper valley.

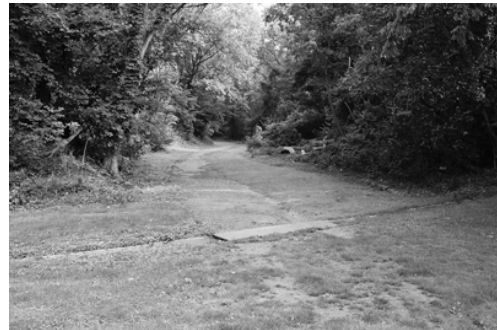
c

c—The upper playing field, from the up-valley side. The diagonal line at the end of the paved path is a concrete ditch that collects surface runoff from the upper valley, diverting that water into the combined sewer system.
