## V. Defining the River Corridor

### The River Corridor Model

A major part of this study focuses on the corridors of the major rivers of Allegheny County. This includes the Allegheny, Monongahela, Youghiogheny and Ohio rivers. These four rivers, all part of the greater Ohio river watershed, are the major hydrological elements of the county's geography. While the watershed section of the study looks at the entire hydrological network of the county, the river corridor analysis zooms in to examine only the sections of the county with a direct spatial relationship with the major rivers. The analysis attempts to measure the ecological functionality of the major river corridors using a combination of field data and GIS analysis of existing mapping.

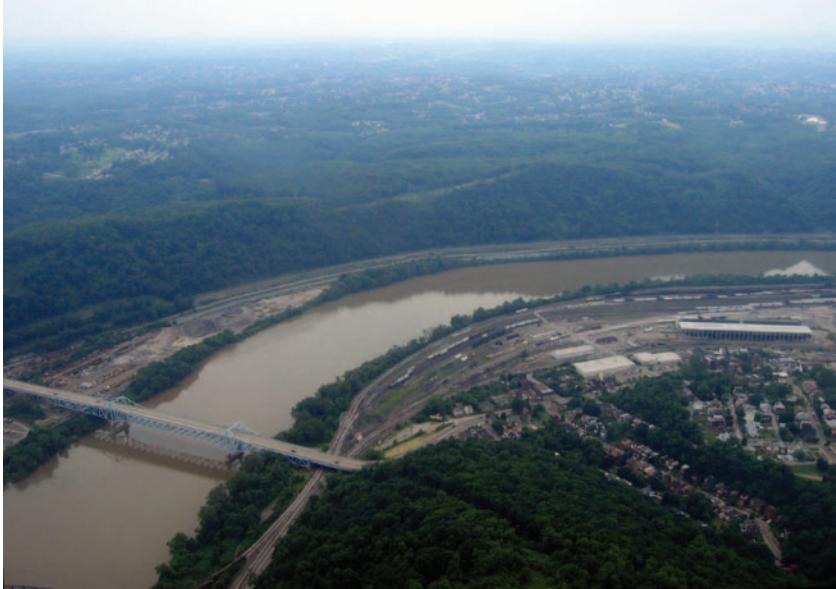
Figure V.5 The Monongahela River Corridor from the air (Photo 3R2N)

A casual comparison of the physical reality with the ecologically optimum model might lead to the conclusion that the river corridors of the county are degraded to the point of having no value. The aerial photograph in Figure V.5 is drastically different from our model in Figure V.6. However, taking a restoration ecology approach, our study argues for the measurement of remnant value, looking for areas of opportunity for preservation, conservation and potential restoration. To do this, a variety of analyses are performed to identify aspects of ecological value that relate to the model.

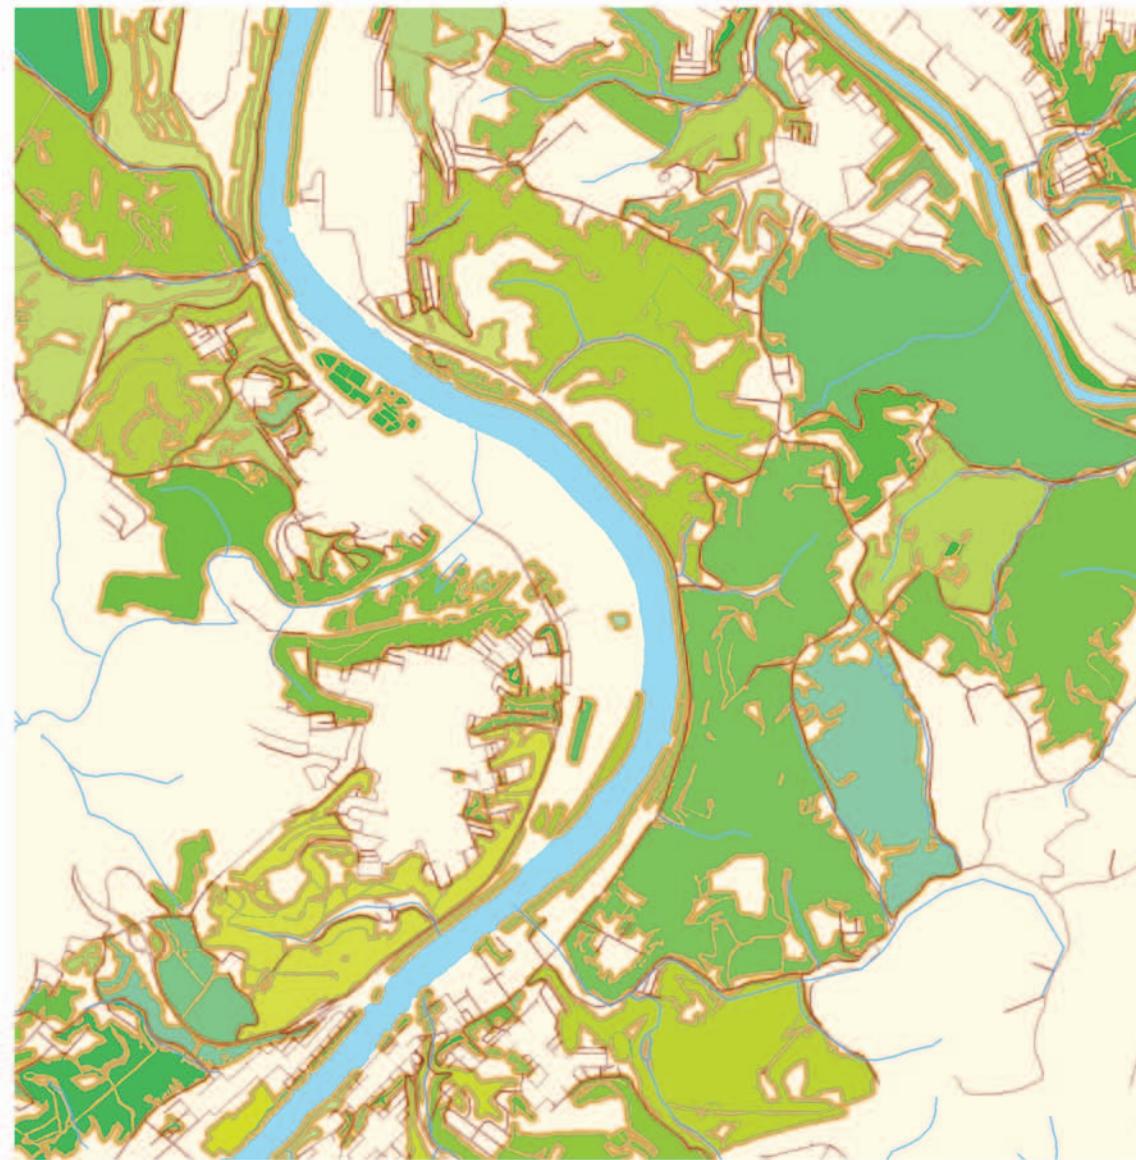
## 6.2 WOODLAND PATCH GROUPING METHODOLOGY

A 100 foot buffer was created for the river corridor woodland patches. Any woodland patches which were within 100 feet from one another were then grouped. These groups were then analyzed for fragmentation by paved roads. If a paved road passed through the 100 foot buffer, the group was broken into two. While these groups display some level of fragmentation, they are not fragmented by roads. Dirt roads, trails and bridges were discounted from the analysis

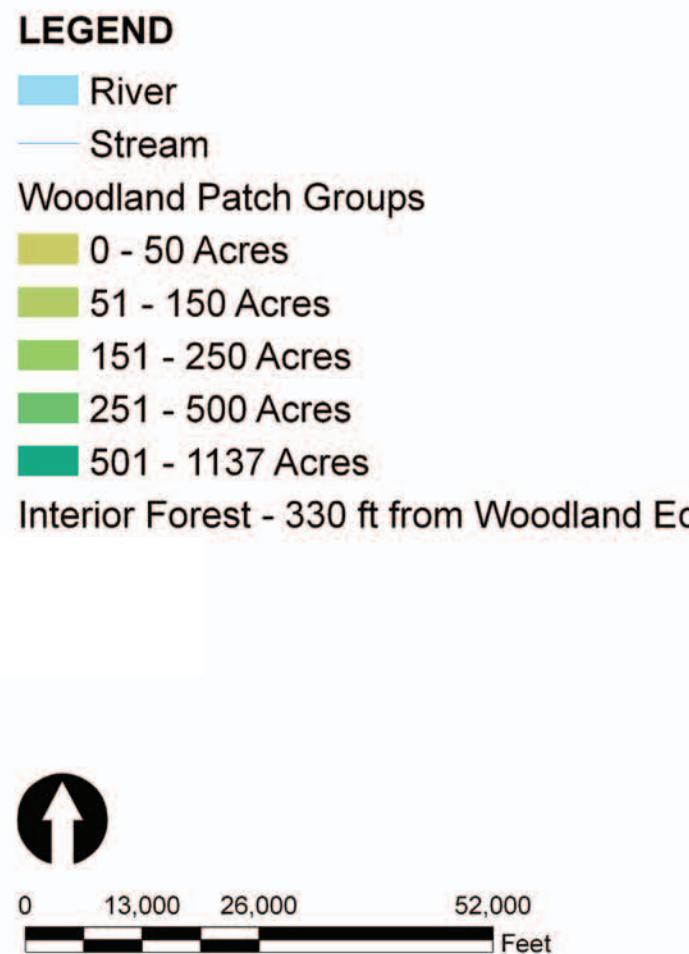
## 6.3 WOODLAND PATCH GROUPS BY AREA

The river corridor woodlands are shown as groups. A group includes any patches within 100' from each other which do not have road separating the patches. Individual groups are shown in different hues.

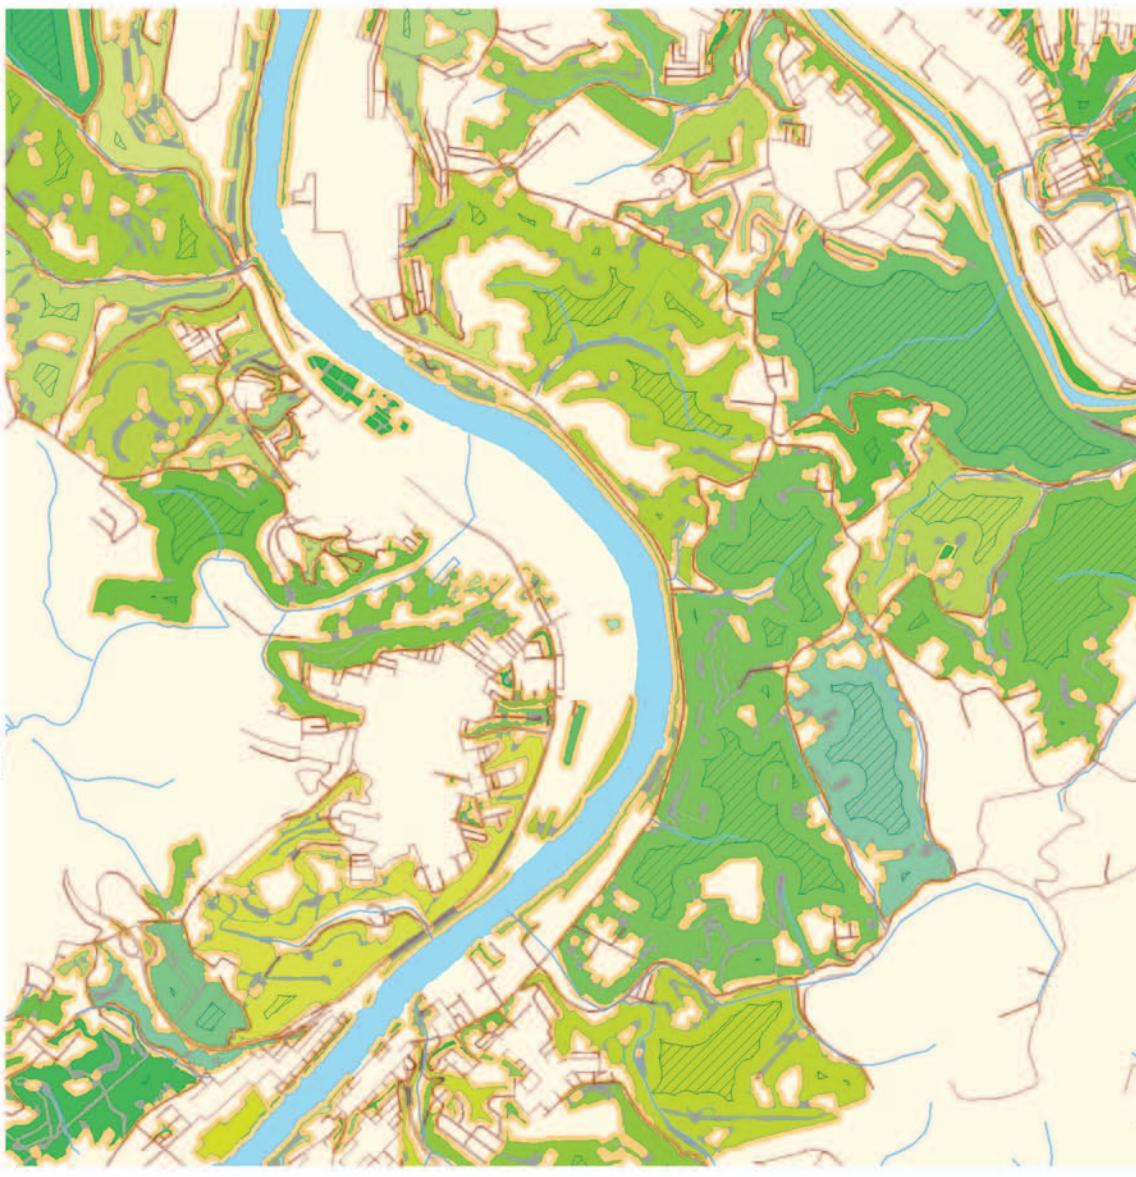
## 6.5 WOODLAND GROUP PERCENT FRAGMENTATION

In order to create a measure of fragmentation for each woodland patch group, the area of the internal corridors was compared to the overall area of the group. This method gave a fragmentation percentage. Note: this methodology tends to generate misrepresentations for very small groups of patches, particularly single patch groups. This is a result of the buffering geometry for small patches of irregular shape.

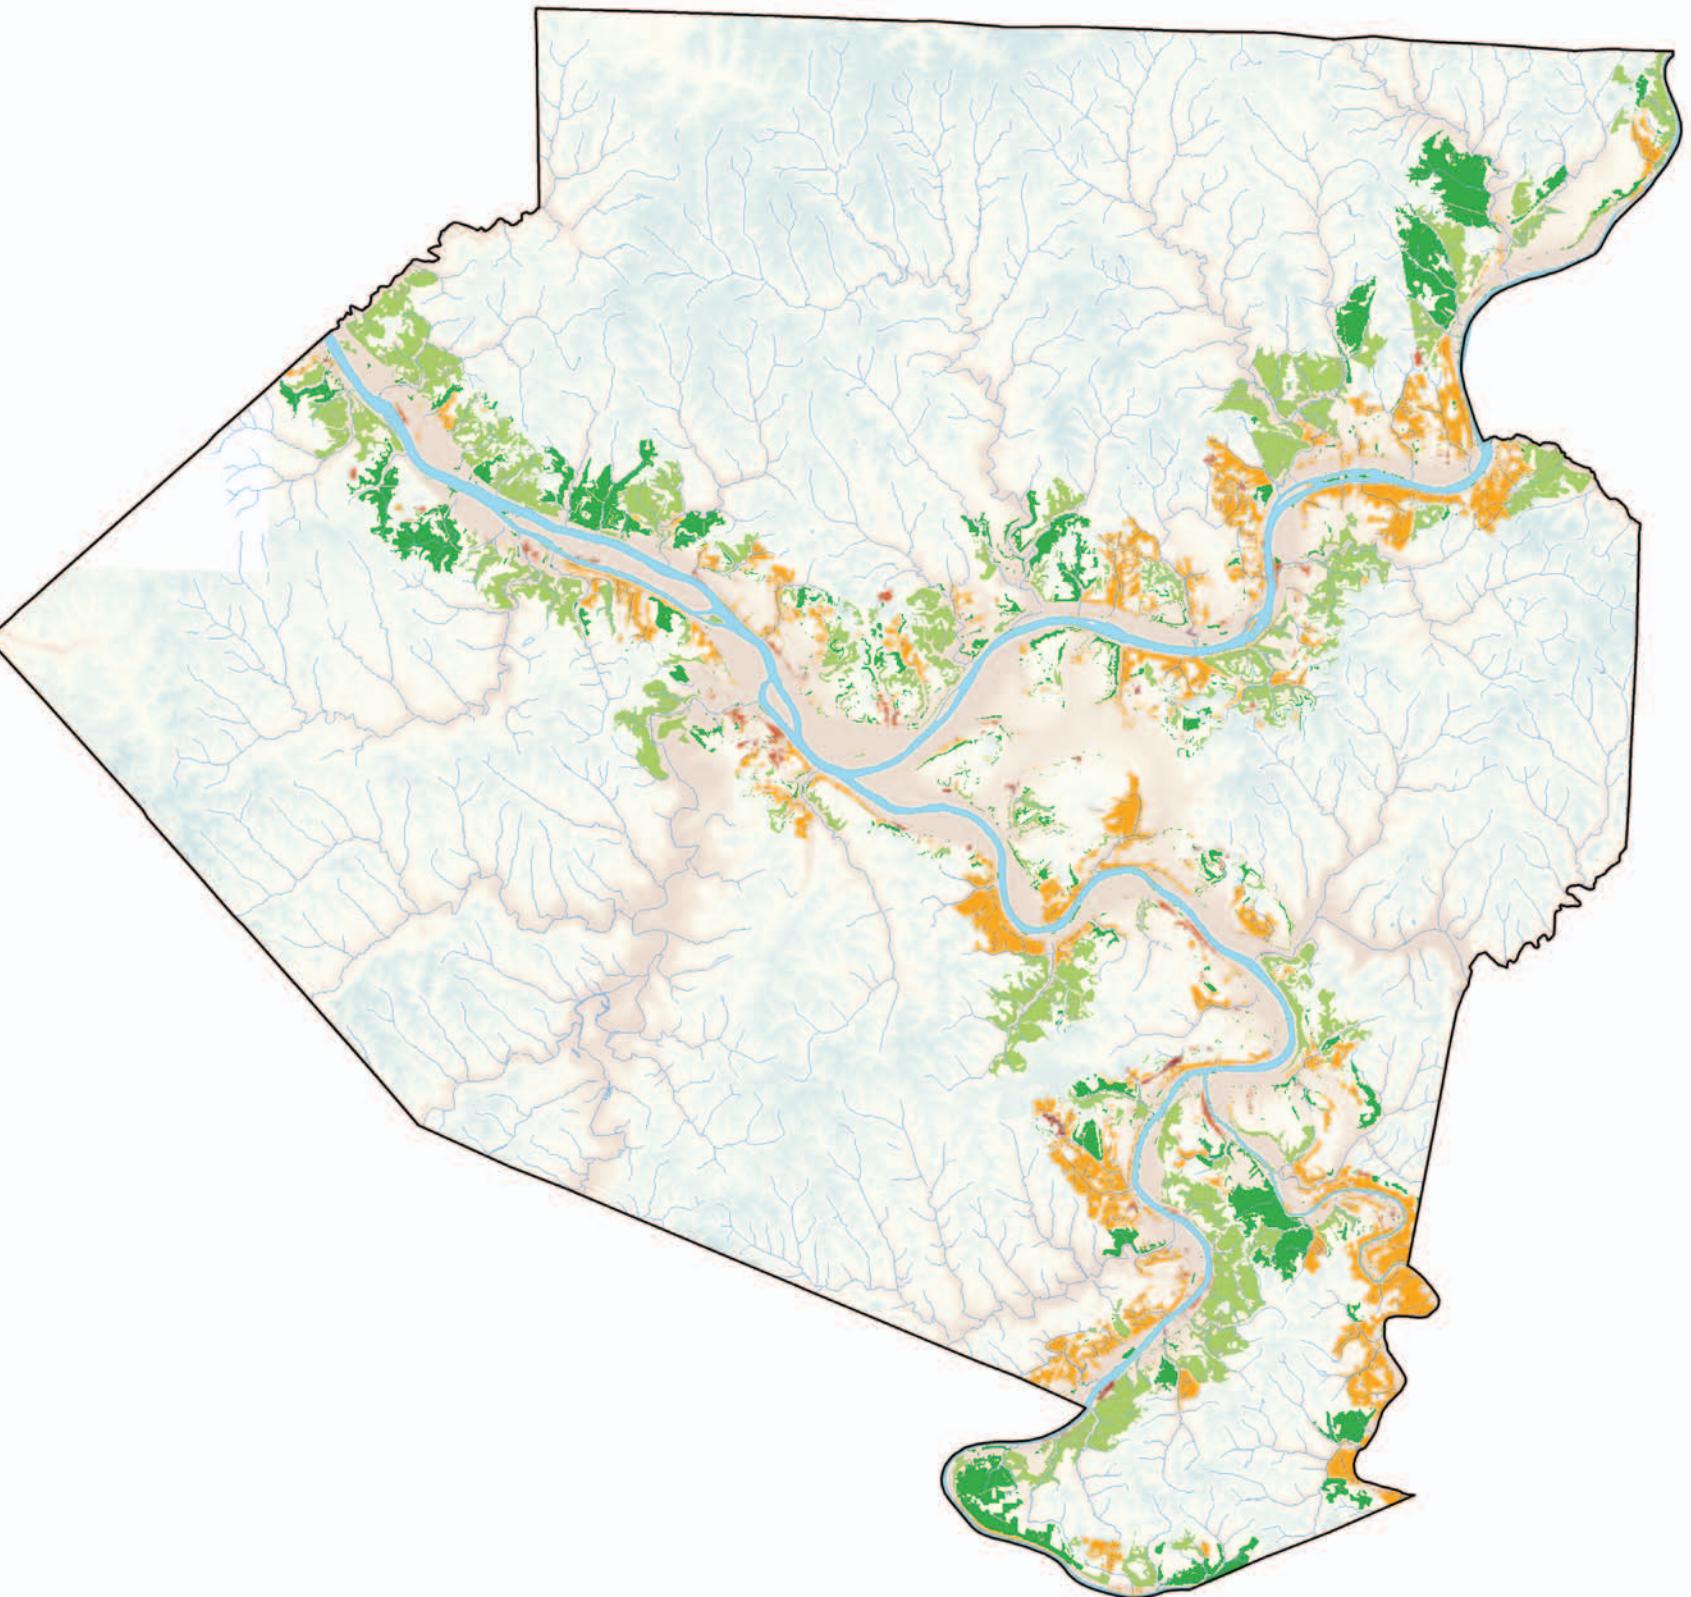
## 6.6 WOODLAND GROUP PERCENT FRAGMENTATION

The percent fragmentation for woodland patch groups based upon 100 foot internal fragmentation corridors. The percent represents area in the missing corridor relative to the total area of the group including the fragmentation corridor.

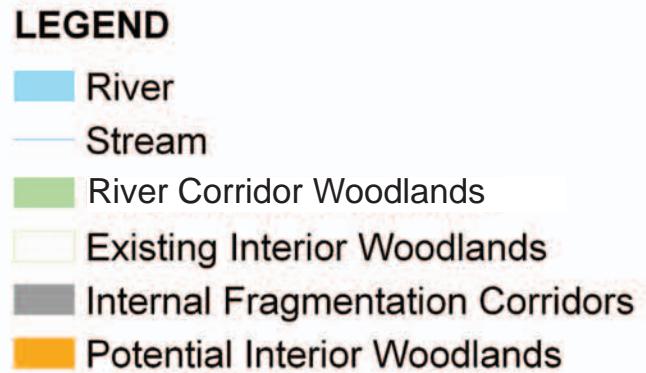
## 6.8 WOODLAND GROUP POTENTIAL INTERIOR WOODLAND

If the internal fragmentation areas were restored to a forested state this would result in an increase in the area of interior woodland. The potential interior woodland of a group was determined using a 330' (100 m) buffer on the woodland patch groups with the internal fragmentation corridors included.

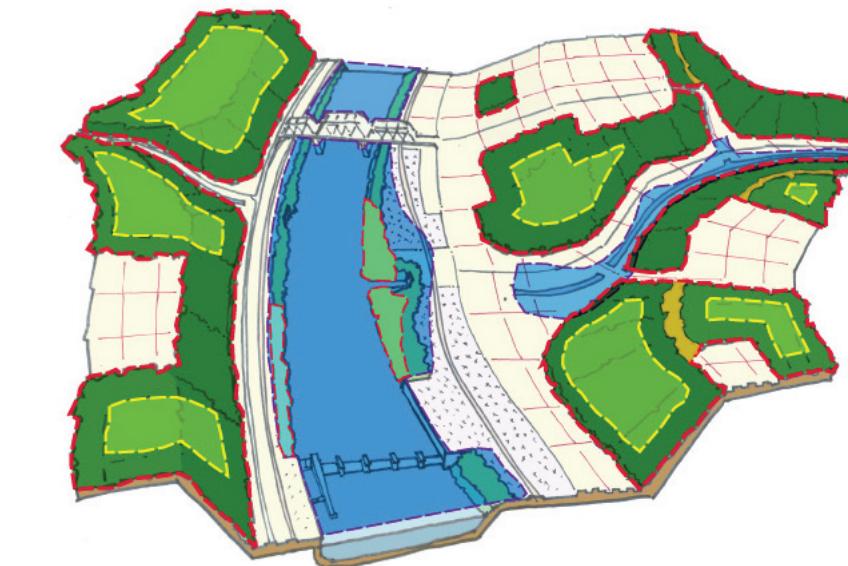
*Figure VIII.2 Measured aspects of the river corridor including bank data and woodland patches used to find remnant value. (Jonathan Kline-3R2N, after Forman)*

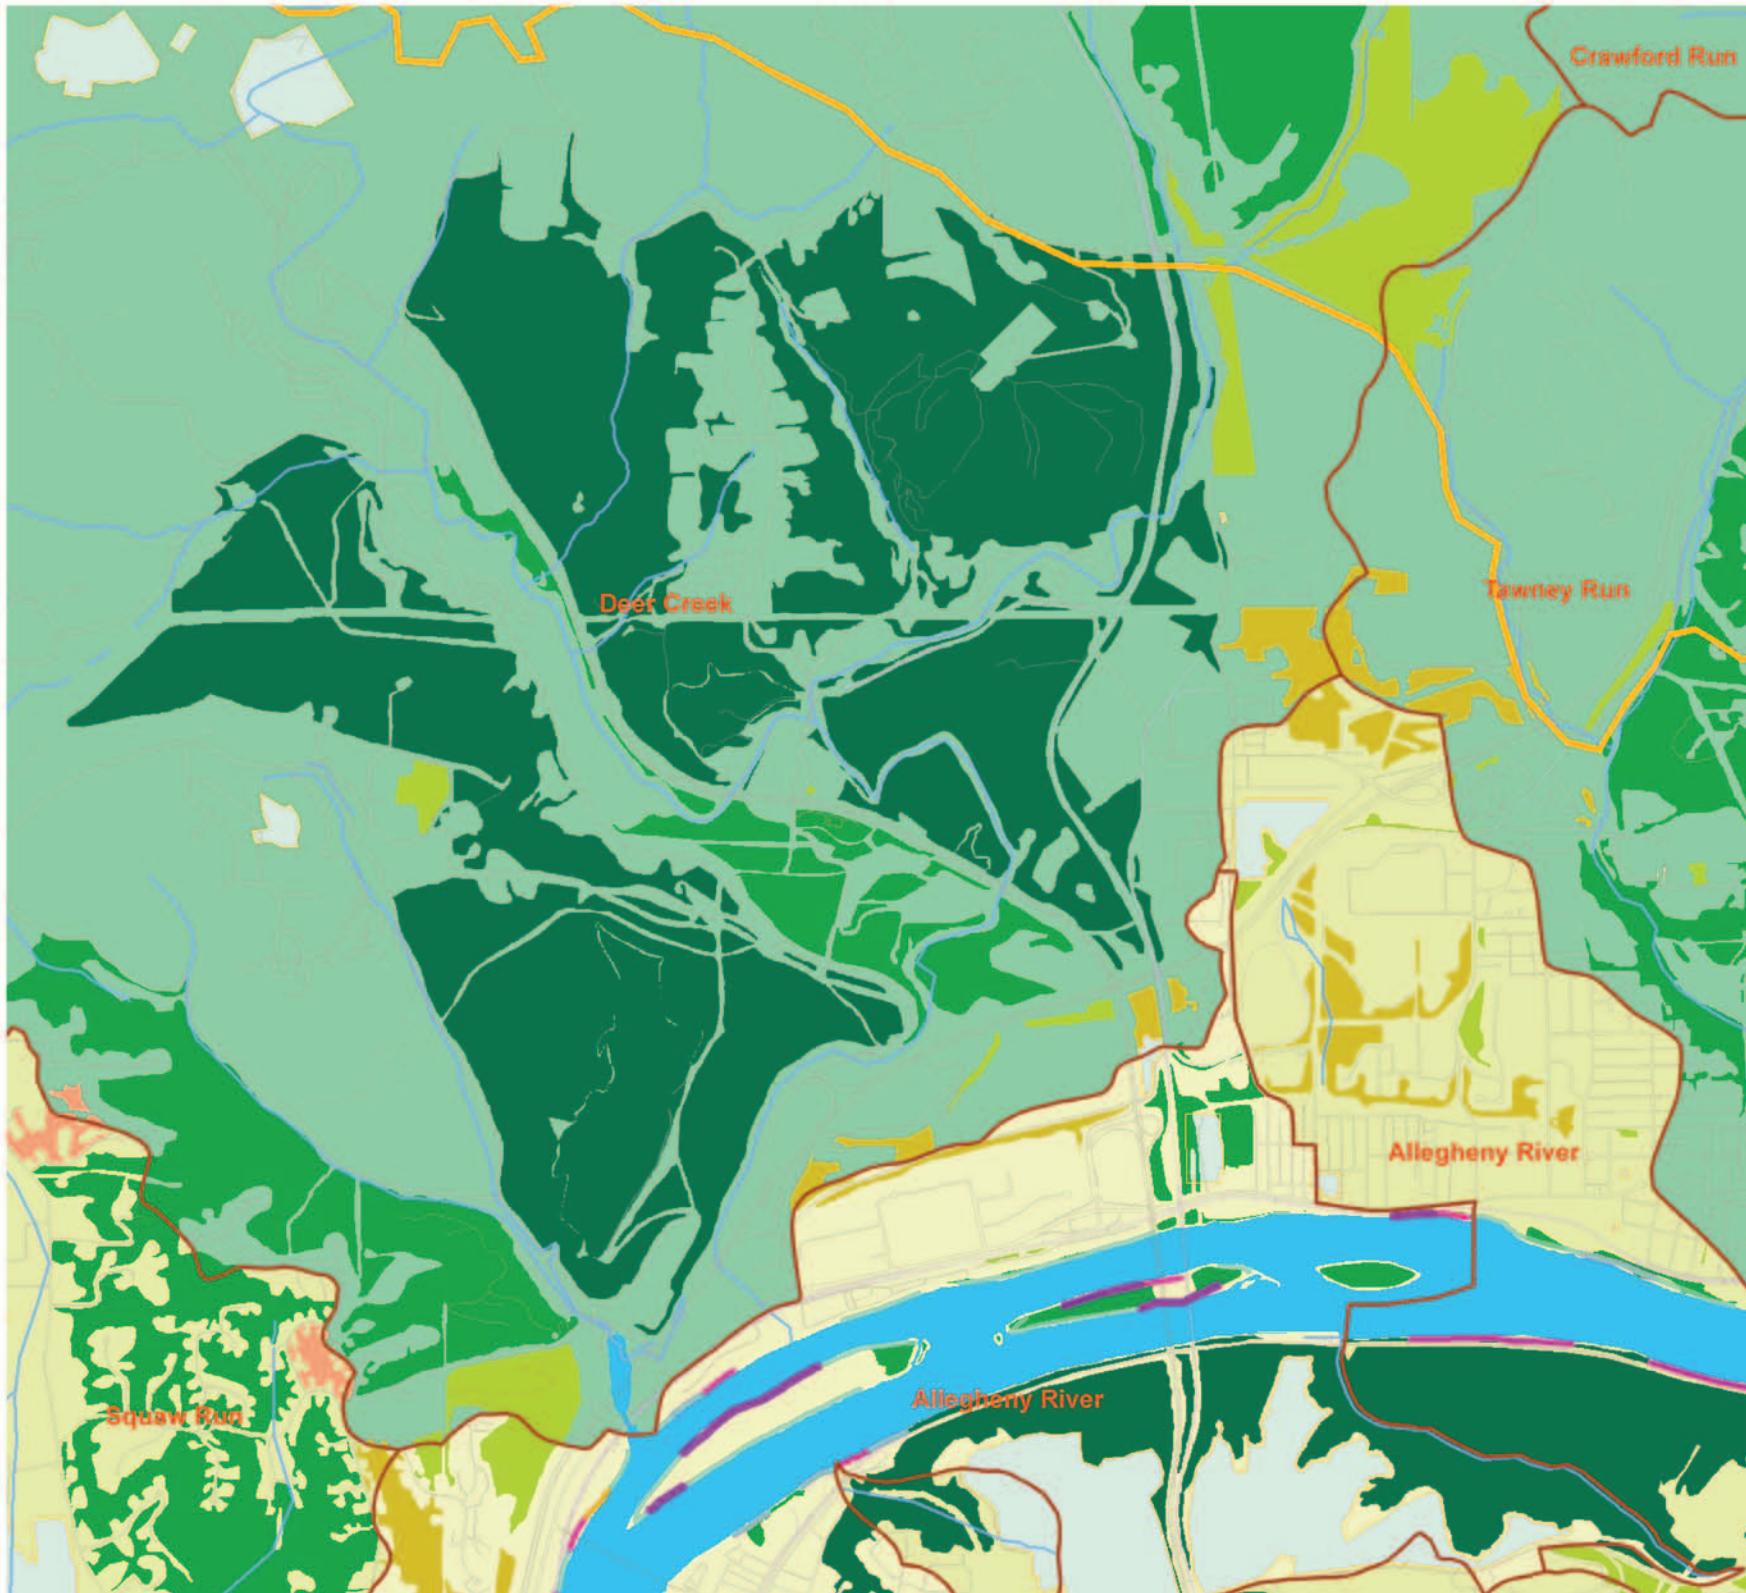
## 8.8 OPPORTUNITY AREA: DEER CREEK

Deer Creek is a significant higher order stream which flows into the Allegheny River at Twelve Mile Island. It is a highly ranked watershed covering a very large northern section of the county. The sections of Deer Creek in the river corridor contain a series of very large woodland patches connected to various sub branches of the stream. Unfortunately the valley of the main branch of Deer Creek also contains a major interstate highway.

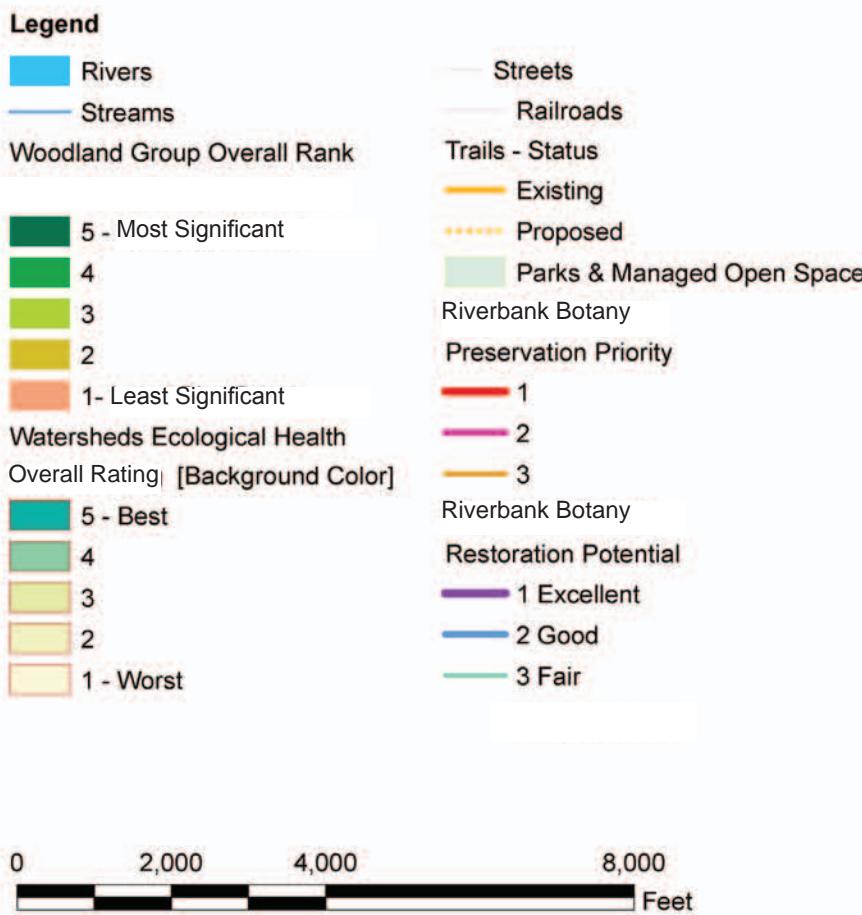
## 8.10 OPPORTUNITY AREA: UPPER ALLEGHENY

The northern shore of the Allegheny River in the northeastern corner of the county contains a very substantial area of wooded hillside with a direct relationship with the river. This area contains four small first order streams and has long stretches of riverbank with high preservation potential. This stretch is particularly significant because the only infrastructure barrier present between the wooded hillside and the river is a set of railroad tracks. A large section of this woodland area is also part of a major public open space called Harrison Hills Park.
