# Ohio River Pools 1, 2, and 3 Riverbank Geology, Conditions, and Access Reports

## **RIVERBANK GEOLOGY, CONDITIONS, AND ACCESS REPORTS**

### **Abstract**

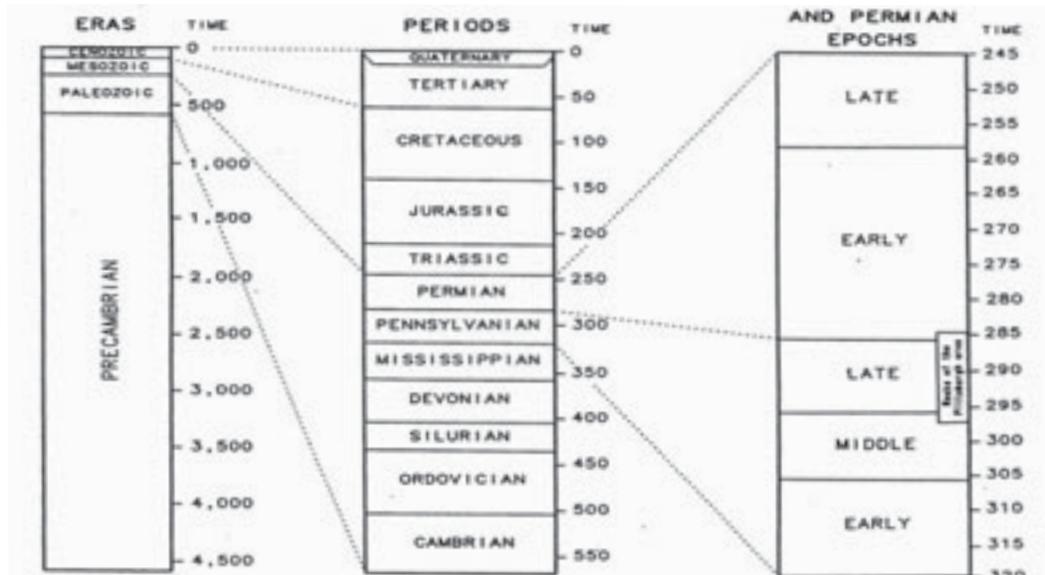
Figure 1.

Simplified geologic time scales, showing the relationships between eras, periods, and epochs. The rock of the Pittsburgh area were deposited mainly during the Late Pennsylvanian. Time is shown in millions of years

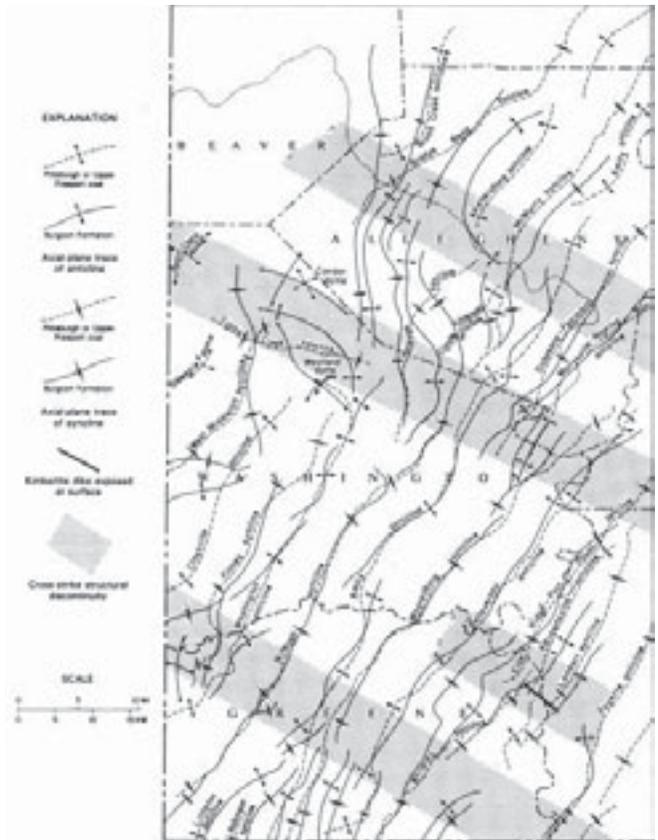
Figure 11.

Structure axes and cross-strike structural discontinuities in southwestern Pennsylvania (structure axes on Pittsburgh or Upper Freeport coal modified from Berg and others, 1980).

The axes, or “ridges” of the rock folds in the Pittsburgh region have a direction that trends northeast; see figure 11, a rock structure map of Southwestern Pennsylvania (Harper and Laughrey, 1987). From this map, the northeastern trends of the folds can be seen, along with four fracture zones that are at right angles, or normal to the regional folds. These are areas of bedrock fracturing that formed during the Appalachian Orogeny, along with the folding. Note that the Ohio River (in Allegheny County) and a portion of the Monongahela River flow along the trend of these fracture zones. The rivers preferentially downcut in these fracture zones, as the bedrock is weaker, and more easily eroded. The fracture zones are caused by very deep bedrock movement during the folding events. Figure 12 (Harper and Laughrey, 1987) shows four geological bedrock block diagrams illustrating some of the processes that lead to the formation

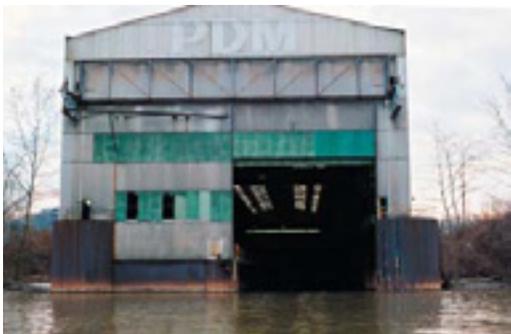
Figure 13.

Figures 13 and 14 show riverbanks that are vertical and have consolidated materials that are manmade. These banks are classified under the “no access” category. Figure 13 is a high steel dock, now inactive, that was once used by Pittsburgh Demoinis Steel Company on Neville Island. This wall is over 25 feet high. Figure 14 is a steel bulkhead used as a dock for Army Corps of Engineers repair facility on Neville Island. These walls are over 20 feet high. Many industrial sites along the Ohio River utilized an unsaleable waste product as a building aggregate, increasing the amount of level land above high flood stage. Other areas of “no access” include the riverfront adjacent to lock and dam structures and portions of the bank blocked by shipping activity. (Figures 15 and 16)

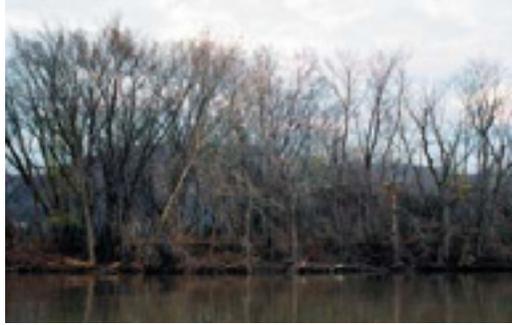
Figure 17.

Figures 17, 18, and 19 are areas that have difficult but possible access. Figure 17 is a photograph of a shoreline that has a fairly steep bank, giving somewhat difficult access from a small boat. An abandoned lock wall (figure 18) is low enough to permit access from larger boats. Landing here in a small boat or canoe would be difficult, due to the wall height of 5 feet. Some shorelines along the Ohio River have possible but difficult access because the property is private, and trespassers would be vigorously ejected by the authorities. An example is shown in figure 19, the large launching facilities of the U.S. Army Corps of Engineers, on Neville Island.

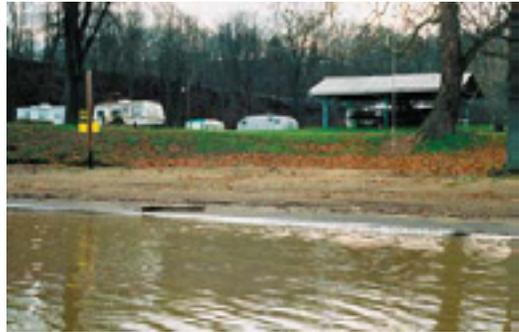
Figure 20.

Figures 20,21,22, 23, and 24 all show bank and berm conditions along the Ohio River that have “easy” access conditions. Figure 20 is a gently sloping sandy berm with a very low bank. A trailer park and campground are on the flat floodplain above this bank, and this locality has ideal access from any small boat. A similar but less developed setting is shown in figure 21, where a sandy berm with some gravel provides an ideal landing point. The most ideal access for most boaters is a paved public launching ramp (figure 22). A berm that consists of gravel only provides easy access (figure 23), and the private boat docks at the end of the old abandoned wall of Lock 2 allow the landowners there ideal access to the river, even though there is a vertical structure present.

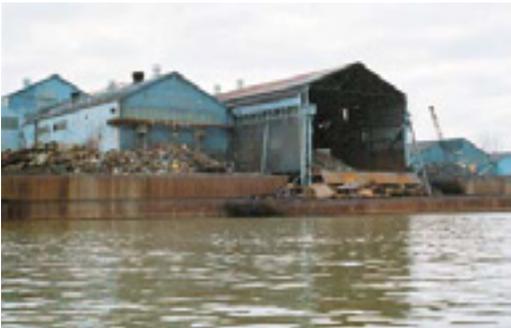
Figure 27.

Man-made bank and berm conditions were observed during the 2003 field season on the Ohio River. Unconsolidated man-made bank and berm materials include steel mill slag, coal mine refuse piles, cement plant waste material, boulders dumped along the bank to stabilize erosion, and rubble material dumped as fill for railroad and highway rights-of-way. Consolidated man-made materials include cement docks and bulkheads, stone and brick walls, structures at water level, steel and wood retaining walls, dumped cement, and solidified slag. Other man-made materials that do not fall into the above categories include odd trash dumped along the riverbank, and occasional wrecks (figure 30). Examples of consolidated man-made bank materials are cement walls, steel piling walls, and cement block walls. Figure 25 is a cement wall built as a foundation for a power plant. In some bank areas, large boulders (known as “rip-rap”) are placed along the riverbank to control erosion. Figures 26 and 28 (a health club and commercial barge docking area) both have non-natural rip-rap bank materials. A large scrap yard at Neville Island has utilized several old barges as a docking area (figure 27), and nearby,

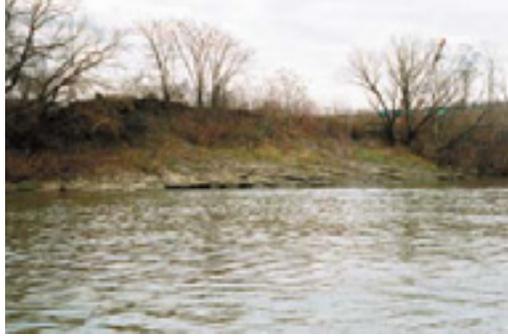
Figure 29.

someone has dumped waste cement and slag, which have both solidified to form a man-made riverbank (figure 29).

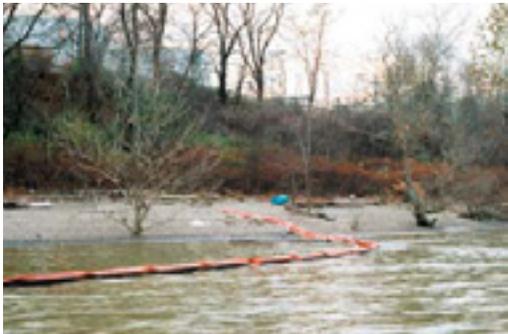
Figure 32.

Figure 32 is a photograph of a large gravel bank on the northeast side of Neville Island. This bank is about 20 feet high and consists mostly of cobble and pebble sized material, with a lesser amount of sand sized grains. Much of this material has been introduced to the area from transport by glacial ice. Much of the exotic material is from the Canadian Shield, which is made up of pre-Cambrian rock ranging in age from 1.2 to 2.6 billion years old. A 1 meter square was imposed on a flat portion of this gravel bank and a cobble count performed; the results are as follows:

- 77% Local sedimentary material (sandstone, shale, etc.)
- 5% Exotic sedimentary material (sandstone, limestone, etc.)
- 17% Exotic metamorphic material (gneiss, quartzite, etc.)
- 1% Exotic igneous material (granite, gabbro, etc.)

The exotic sedimentary cobbles were identified by fossil content and species; this percentage could be higher if ambiguities in field identification were eliminated. Most fossils collected from introduced sedimentary rocks were of Silurian age (figure 1, Geological Time Scale) and these rocks are exposed on the surface in the Buffalo, New York area, but deeply buried in the Pittsburgh region. Since there are no surface exposures of metamorphic or igneous rocks within the Allegheny River drainage basin, these cobbles are definitely of exotic origin, even though they were transported and deposited by natural processes. Metamorphic rocks occur about 16,000 feet deep in the Pittsburgh area.

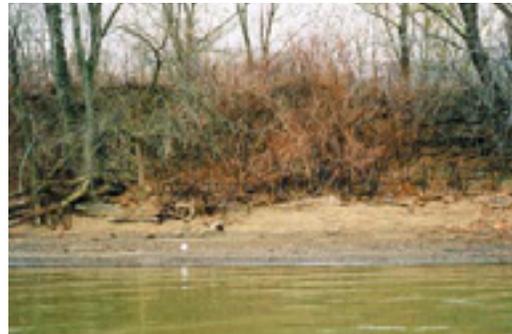
Figure 33.

A riverbank with natural materials of a smaller grain size is shown in figure 33. This low Bank (about 12 feet high) consists mostly of sand, with some gravel nearer to the berm. This is a good example of a low floodplain deposit, where the materials are eroded and transported more frequently than higher more competent bank materials during flood stages. Figure 34 shows the southernmost tip of Neville Island; most of the material here is mud, with some intermixed sand.

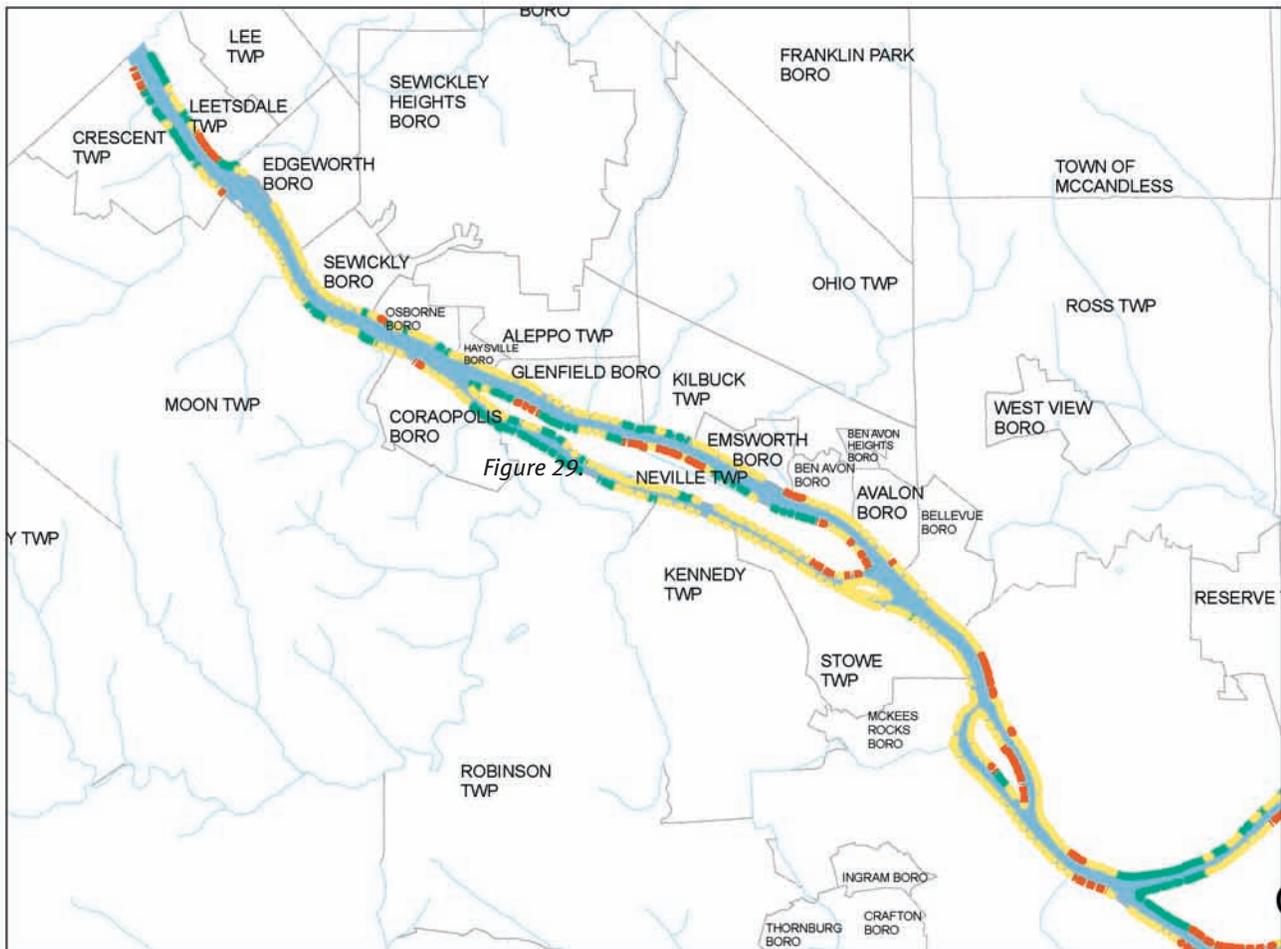
Figure 35.

An ideal area of riverbank access would have deep water for an easy approach by powerboat, a sandy berm with some pebble-sized material for added competence, a shallow berm slope, and a minimum amount of plant undergrowth. Other ideal access areas include man-made launching areas and other riverbank portions that have had access improved. The three grades of access have been plotted on a map of the Ohio River study area using GIS computer mapping methods (figure 35).

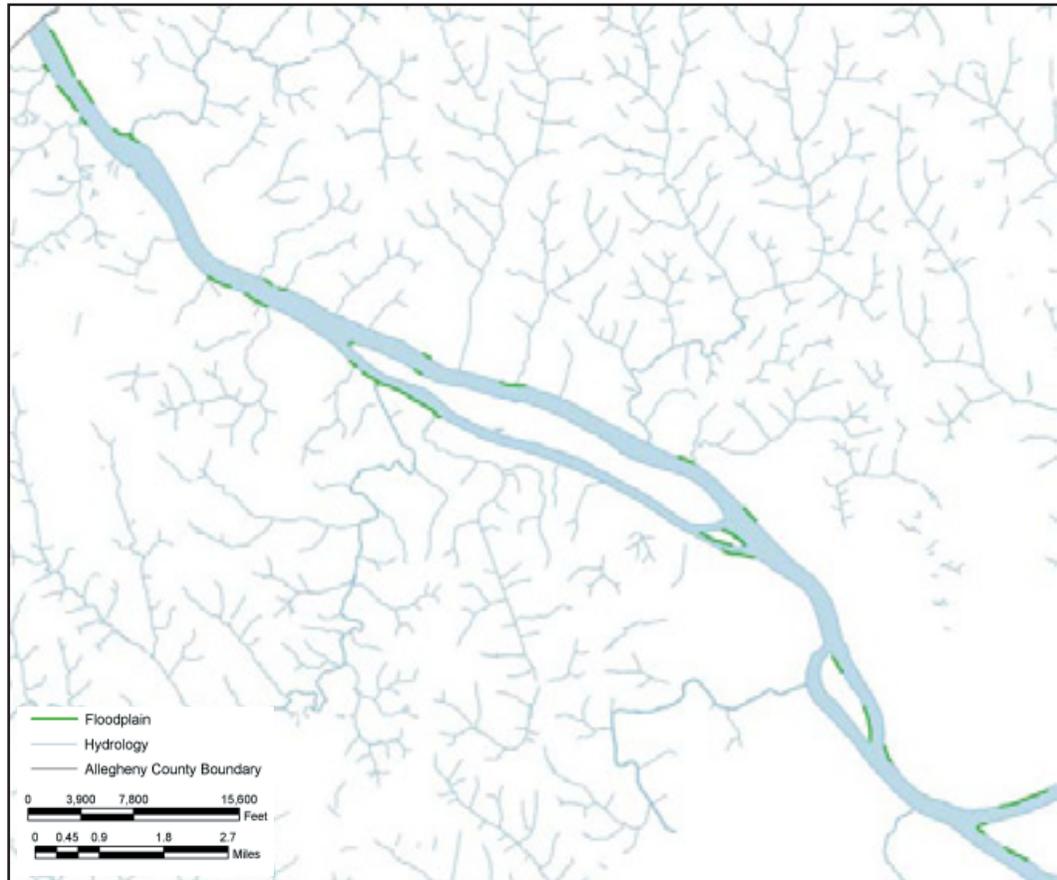
Figure 36.

After selecting these floodplain areas, a map was generated showing these areas bounded by floodplains (figure 36).

areas of P1, P2, and P3 imply a descending surface area value for each case. P4 preservation grade is simply whether a floodplain is present (figure 36).

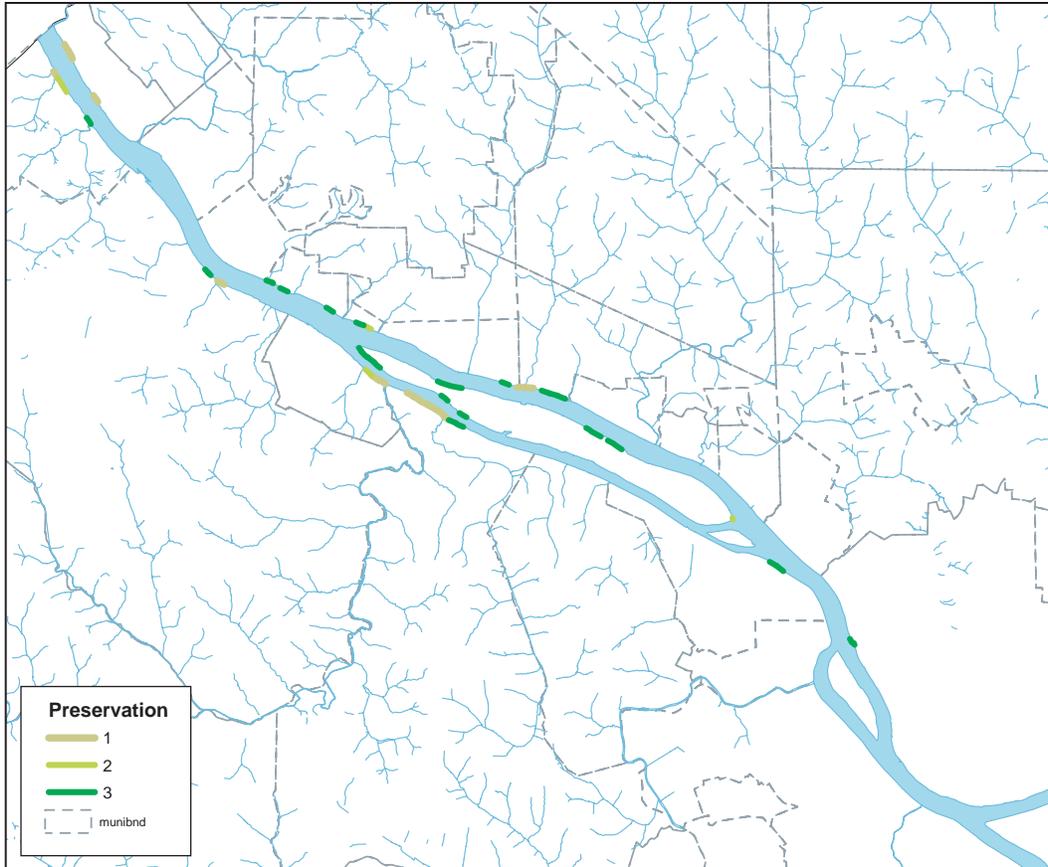
Figure 41.

These data operators were entered into the ARCINFO computer mapping program and a map of the riverbank section's preservation potentials were plotted (figure 41). A fold out map of the total 3R2N study area (Allegheny, Monongahela, Ohio, and Youghiogheny Rivers) showing the grades preservation and restoration is pictured in figure 35.1.

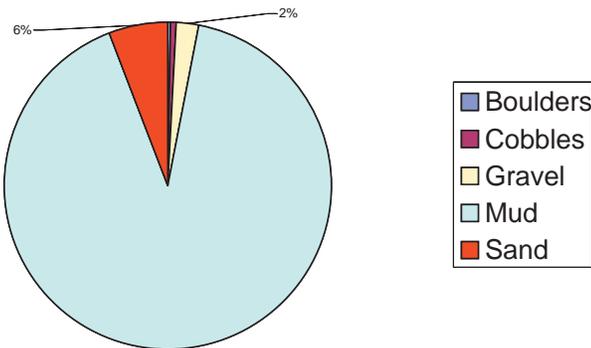
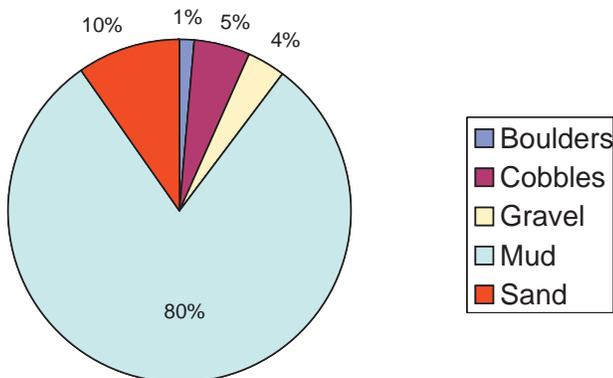
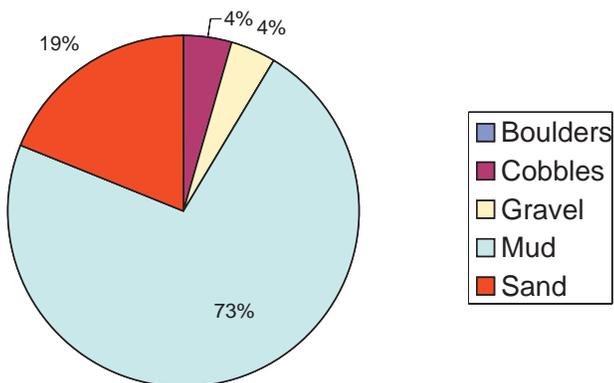
Figures 46, 47, and 48 are “pie” charts that show natural materials and grain sizes for pools 1, 2, and 3 of the Ohio River. Grain size trends for man-made materials are not relevant, as they were not deposited through long-term natural geological processes. In general, there is a trend of finer grains along the upstream direction. This is an opposite trend for most rivers and streams even though material was added to the system from the Allegheny River, resulting from glacial outwash deposit erosion and transportation. Pool 1 has 92% mud, pool 2, 80%, and pool 3, 73%. The amount of sand decreases upstream, and the cobble/gravel values decrease upstream, also.

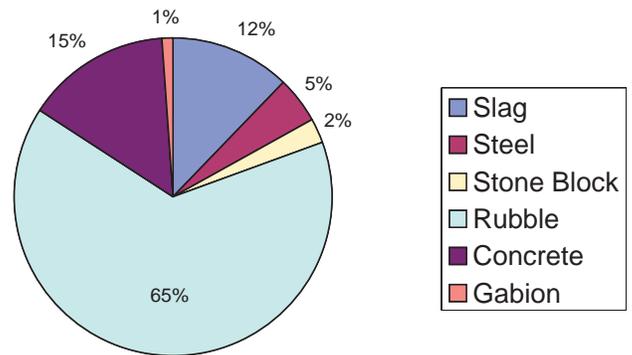
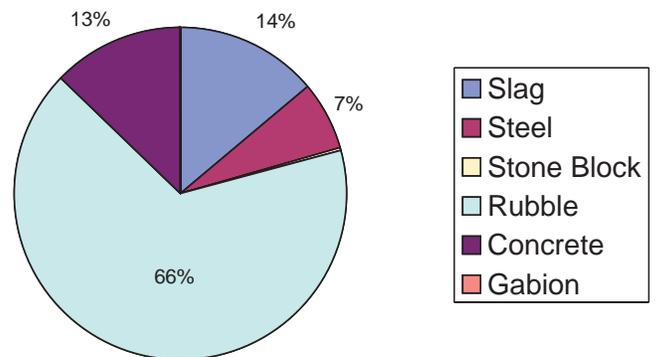
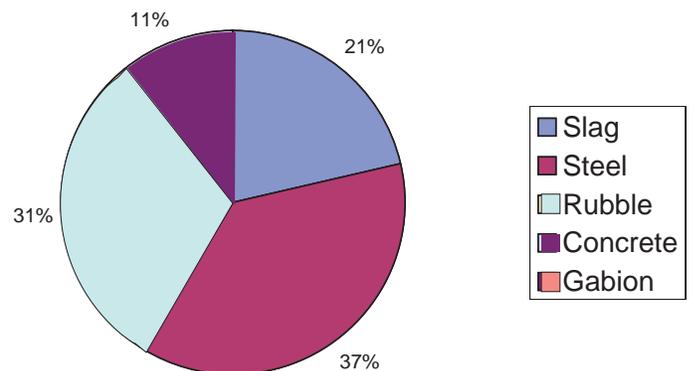
Figures 49, 50, and 51 are “pie” charts showing percentages of man-made riverbank material in pools 1, 2, and 3 of the Ohio River. In general, there is an increase of historical heavy industry (particularly steelmaking) along a downstream stream direction. The largest steelmaking site on the Ohio River was in pool 3, at the old American Bridge Division of United States Steel Company in Ambridge, PA.

Most other heavy industrial activity along the Ohio River was steel fabricating, (such as Pittsburgh Demoines Steel Co.) which generates little or no slag. These riverbank industries can be correlated to the amount of slag found as bank material; pool 1 has only 12% slag, where pools 2 and 3 have 41% and 21% respectively.

The amount of rubble and fill decreases fairly consistently downstream over the study area; at pool 1, (65% rubble/fill) there was a greater amount of fill dumped over time to increase land area in and near the City of Pittsburgh. Pools 2 and 3 have a lesser amount of rubble and fill, due to railroad construction along both riverbanks (66% and 31%, respectively). The amount of concrete (used for retaining walls and freight docks) is about the same for pools 1, 2, and 3.

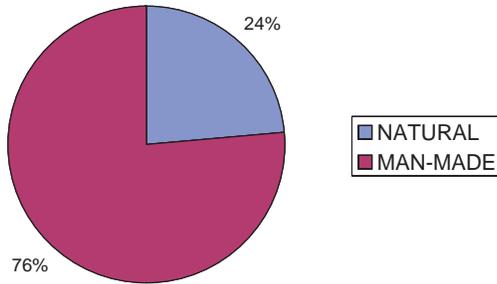
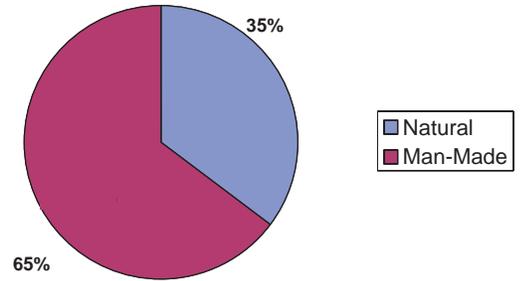
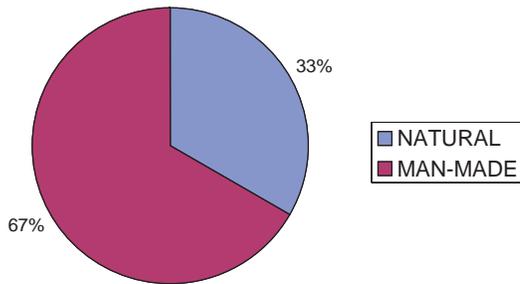
A general decrease of man-made bank materials can be traced along the downstream direction (figures 52, 53, and 54). Even though there is no increase of industrial activity in the upstream portions of the study area, the impact of the City of Pittsburgh and other historical building

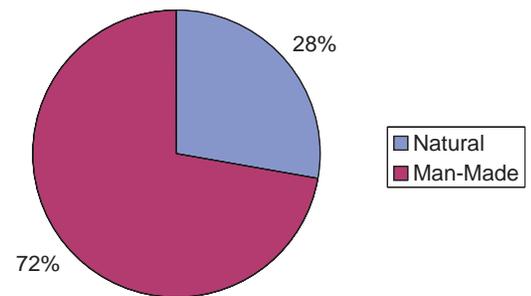
Figure 55. Ohio River: Man-Made to Natural Materials

activities result in the trends seen in the chart figures. Figure 55 is a chart with the total average amount of natural vs. man-made material percentages for the whole Ohio River study area, with 28% natural bank materials and 72% man-made material.
