Appendix B: Schenley/ Junction Hollow

Appendix C: Sheraden Park

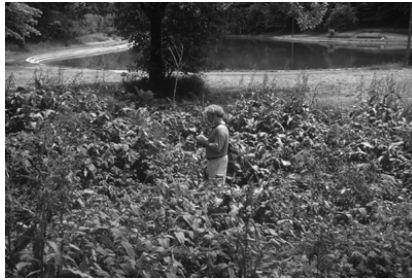
C—Looking down on Panther Hollow Lake from near Phipps Conservatory. The railroad tracks and Junction Hollow are at the far end of the lake

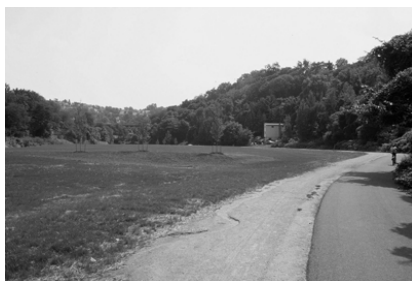
H—A view south in the depression that forms a lower level in Junction Hollow, about 15-20 feet lower than the level of the recreation path.

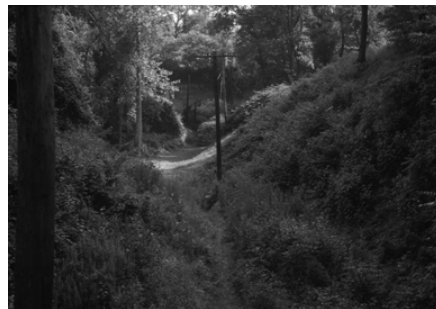
g

g—The valley below the softball field. The arch of the railroad causeway tunnel is just visible.
